# Installation

## Aerada™ 900 Series Futura Faucet

With Accu-Zone® (AZ) Infrared  
Control

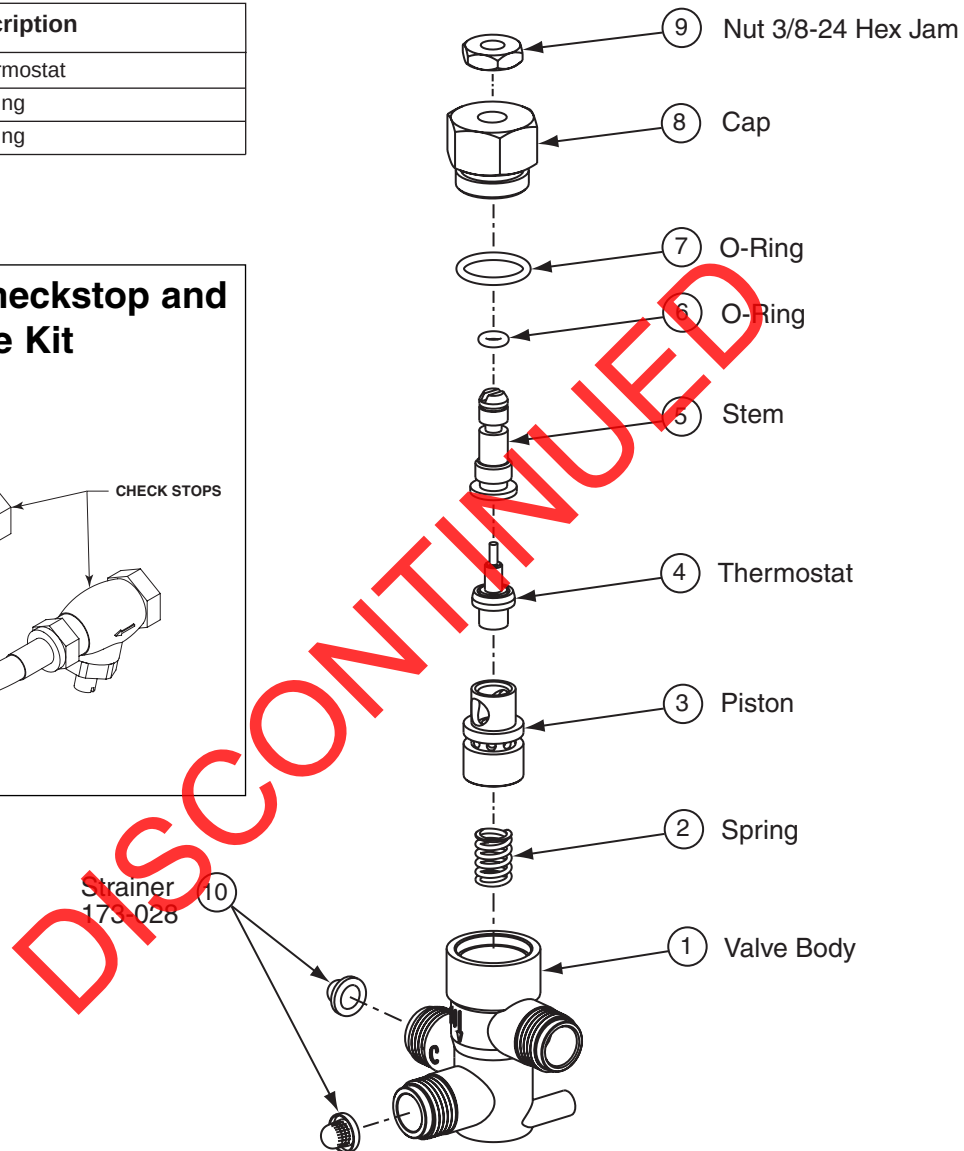
# Vernatherm™ Thermostatic Mixing Valve

## S59-4004XS

### Repair Kit S65-259
