IMPORTANT!
READ FIRST IF ROTATING REFLECTOR!

SUPPLEMENTAL INSTRUCTIONS – TYPE “FR” HILTON SERIES

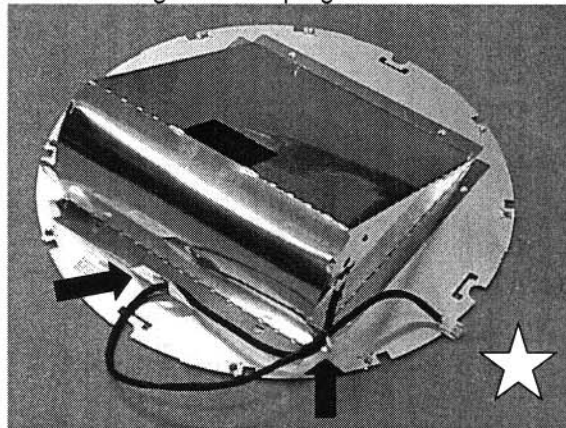
FIGURE 1 Route harness through side loop again.

This reflector can be rotated to 3 positions for optimum light direction. This also places the ballast in 1 of 3 positions in relation to reflector. You must re-route wiring if rotating reflector from fixture's as-shipped position. Match ballast location in relation to reflector using below figures. Star represents ballast, arrows point to loops.

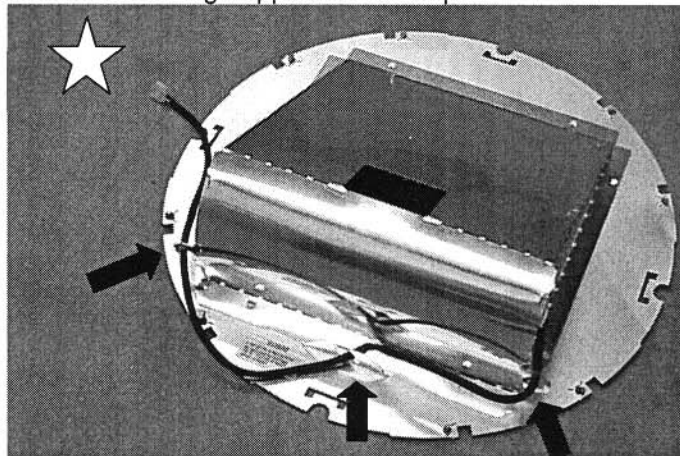
FIGURE 2 Route harness through opposite side loop.
